EVALUATING CAUSES OF ROAD FAILURE ALONG KM 5, ADO-IKERE-EKITI ROAD, SOUTHWESTERN NIGERIA

Ajayi, C. A.^{a*}, Abdu-Raheem, Y. A.^a, Talabi, A. O.^a, Ilugbo S.O.^b^aDepartment of Geology, Ekiti State University, Ado-Ekiti, Ekiti State^bDepartment of Physics, Lead City University Ibadan, Oyo State*Corresponding Author Email: christopher.ajayi@eksu.edu.ng

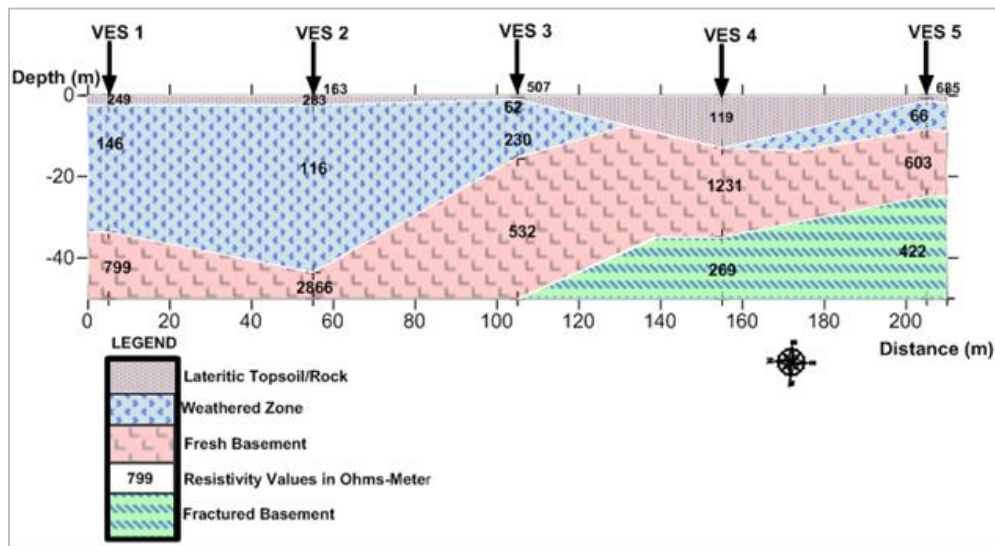
Figure 3: Goelectric Section along the Studied Road

The geo-electric parameters derived from the five VES stations were used to generate the geo-electric section of the study area. The geoelectric section (Fig.3) shows the variations of resistivity and thickness values of layers within the depth penetrated in the study area at the indicated VES stations. Four subsurface geo-electric layers which are; the topsoil, weathered zone, fresh basement, and fractured basement. The topsoil resistivity values ranged from 249-685 ohms-m with a thickness range of 0.6 - 12.8 m. The topsoil is made up of lateritic-sandy soil. The sands originated from the weathered quartzite formation of the study area.

The second layer is the weathered zone with resistivity values ranging from 52 - 230 ohms-m and thickness from 0.7- 31.2 m; the weathered formation can be observed in VES 1, 2, 3, and 5. The third layer is the fresh basement with resistivity values ranging from 532-2866 ohms-m. The fourth layer constitutes the fractured zone of the study area with resistivity values of 269 - 422 ohms-m. The study revealed that the partly competent lateritic topsoil is very thin along distances 0 to 100 m; which was underlain by a highly thick 10 to 40 m weathered formation. These have rendered the road reconstruction work ineffective. The quantity of hardcore to fill a 40 m depth is not economical. Also, the fractured zone underlying the stable bedrock has contributed to the failing of the road uphill along distances 105 to 210 m of the study area as a result of the weight of heavy-duty vehicles plying the road. It was noted during the study that the drainage system of the road is not adequately taken care of.

The blockage has also aggravated the continuous failure of the road.

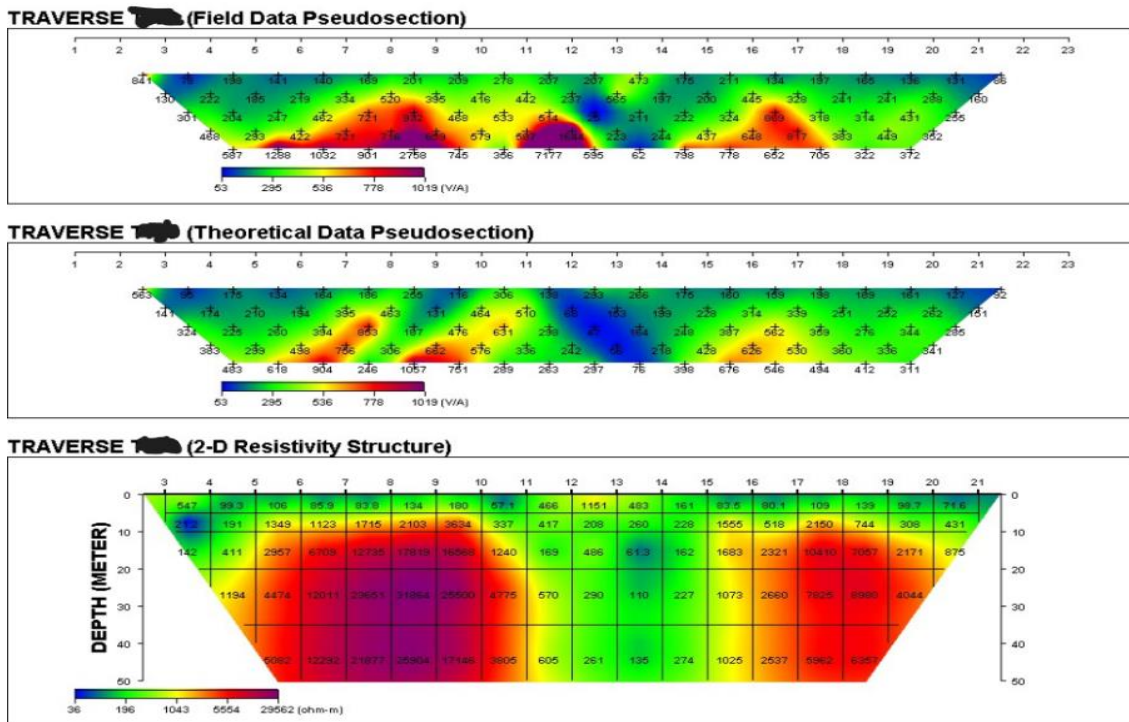
Figure 4: The 2D resistivity structure of the study area

The 2-D pseudo-section was produced along the single traverse (Fig. 4). The blueish color represents a highly weathered/clayey zone, the green color indicates a weathered formation, the yellow color shows a partly weathered formation while the red color signifies fresh basement with resistivity values ranging from 36-160, 161-847, 848-4511 and 4512-5554 ohm-meter respectively (Fig. 4). The study has revealed weathered formation at the depth ranging from 0-20 m. Very deep fractured formation was also observed within distances 110 to 160 m which could not be captured by the VES approach. This hollow-fractured formation revealed by the dipole-dipole arrangement has suggested the possibility of a buried stream channel across the study orientation in an East-West direction.

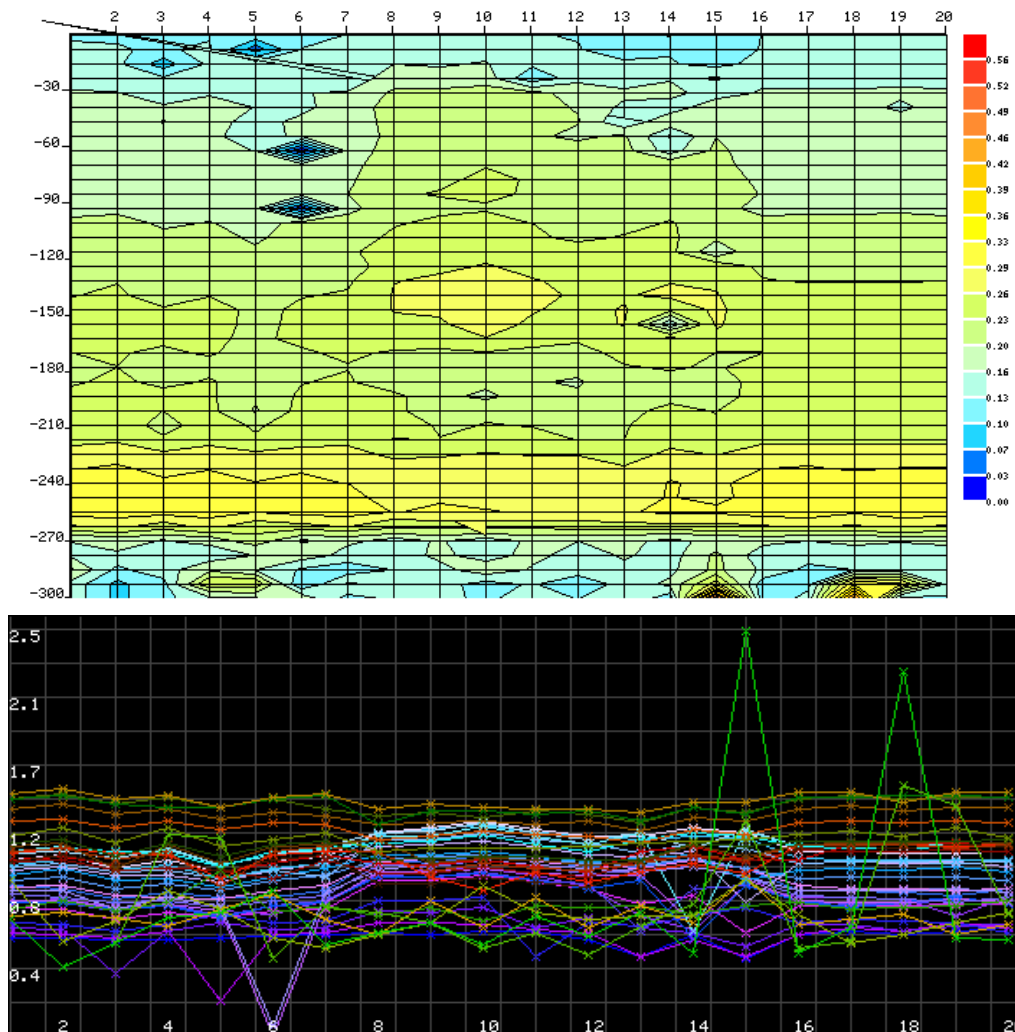
Figure 5: Pseudo-Section of the Frequency Effect Ratio Percentage of the Electromagnetic Waves and the Generated Profile Map along the Study Area.

The electromagnetic Impact method was also used with Gradient Array techniques to unravel the causes of road failure along Km5, Ado-Ikere – Ekiti road. Fig. 4. Indicating electromagnetic spectra revealed a highly

weathered zone with blue coloration reflecting conductive zones with frequent effect percentage(FEP) range of 0 - 10% representing the clayey zone, 11-36% with greenish color representing the fairly weathered zone and yellowish to reddish zone signifying the fresh basement/stable bedrock with above 36% FEP.

Also, some fractured formations were revealed at distances 50, 60, and 140m at 5, 60 - 90 m, and 91-110m depth respectively. The frequency effect percentage represents the apparent resistivity variations within the subsurface. This approach captured 300 m depth of the study area. It revealed the occurrence of fractured bedrock at the depth of 47- 63 m, 86 - 100 m, and 270 to infinity along the traversed path of the road. The Electromagnetic method further revealed the possibility of the buried river channel at a depth of 270 m and above across the study area.
